Fuel Containment of Auxiliary Fuel Tanks

March 1995

DOT/FAA/CT-TN94/17

11. Contract or Grant No. DTFA03-89-C-00043	
12. Sponsoring Agency Name and Address U.S. Department of Transportation Federal Aviation Administration Technical Center Atlantic City International Airport, NJ 08405		13. Type of Report and Period Covered Technical Note

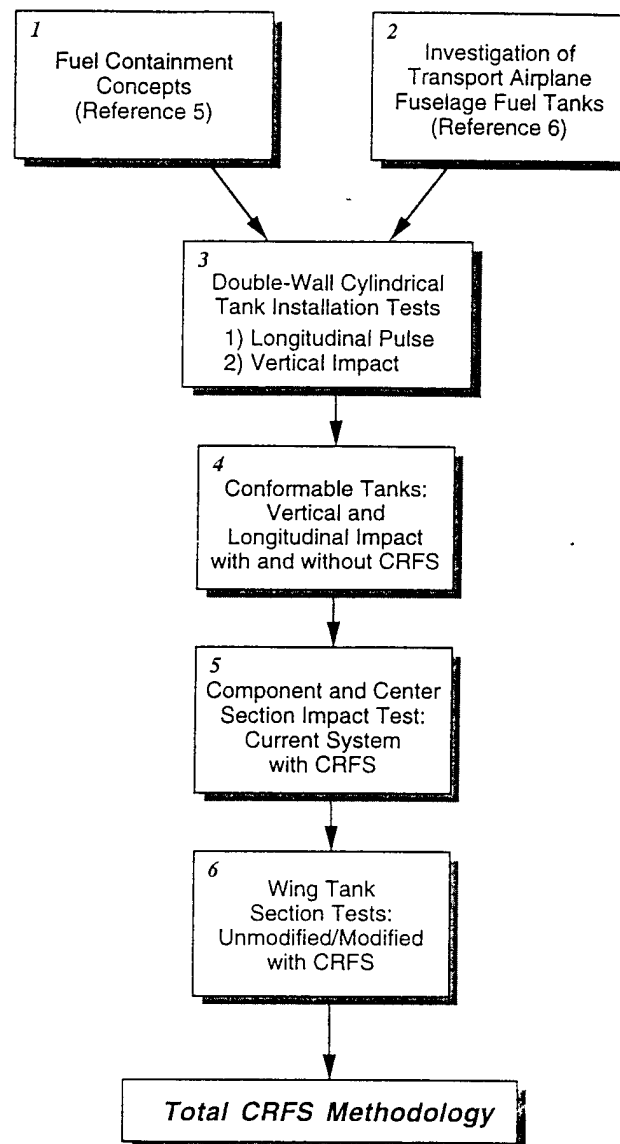
FIGURE 1. PROPOSED FUEL TANK INSTALLATION TEST PROGRAM

The three major domestic transport airplane manufacturers under contracts to the Federal Aviation Administration (FAA) and the National Aeronautics and Space Administration (NASA) (references 1-3) performed a comprehensive evaluation of FAR 25 airplane accidents from 1960-1979. Postcrash fires were noted as a major area of concern. The results of the Controlled Impact Demonstration (CID) crash test in 1985 (reference 4) suggested that alternatives to fuel additives for reducing or eliminating postcrash fire fatalities or injuries should be considered. The FAA initiated a program to investigate fuel containment concepts. Figure 1 illustrates the overall program as it was initially proposed.

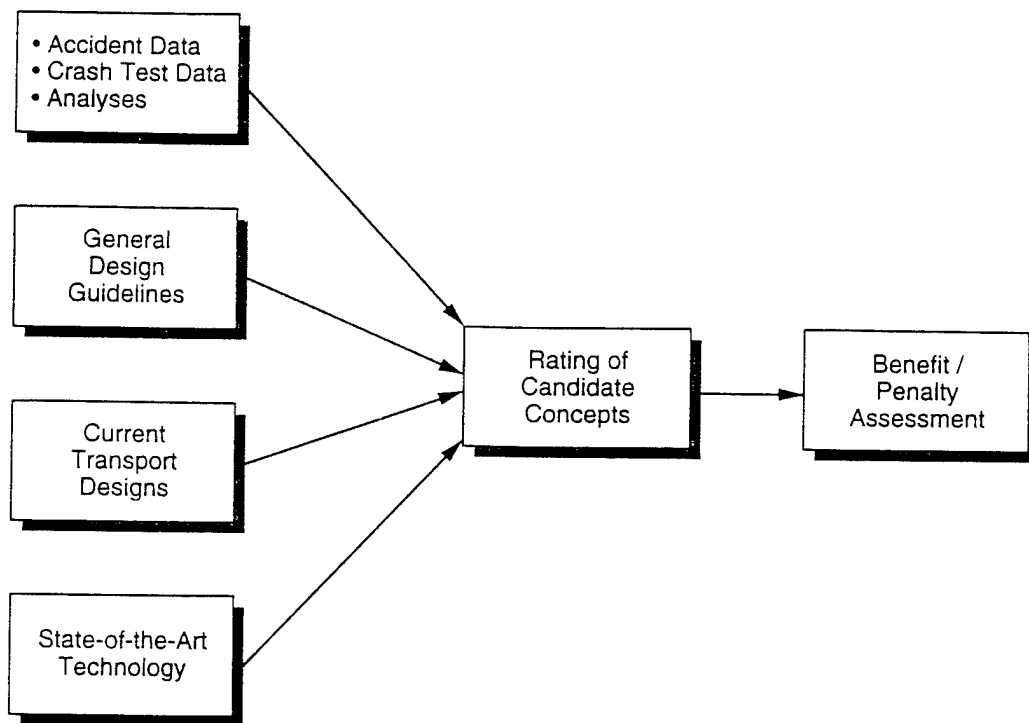
FIGURE 2. TRANSPORT CATEGORY AIRPLANE FUEL CONTAINMENT CONCEPTS

The tasks previously completed, before this current effort, are described in references 5-7. The flow diagrams for the initial “fuel containment concepts” and the subsequent “investigation of installations under crash loads,” are shown in figures 2 and 3. The most recent task (reference 7) included a longitudinal-pulse test of a fuselage section with a double-walled floor-mounted cylindrical auxiliary fuel tank. The FAA sponsored research also includes a vertical impact test of the same fuselage section with the same double-walled auxiliary fuel tank installed (reference 8). This latter test also included overhead bins and seats as well as the double-wall cylindrical auxiliary fuel tank, which is being evaluated by the FAA, research with regard to auxiliary fuselage fuel tank installations performance under crash impact conditions is ongoing. The objectives of the current effort described herein, is as follows:

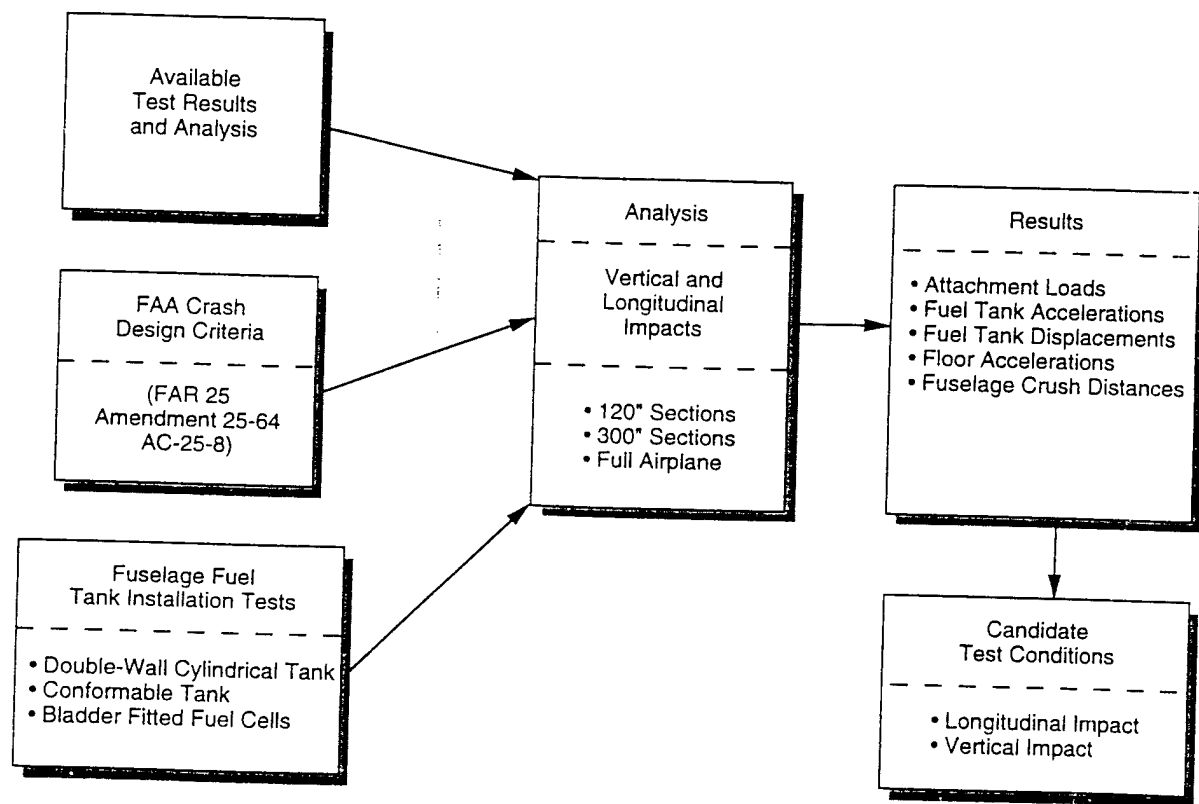
FIGURE 3. INVESTIGATION OF TRANSPORT AIRPLANE FUSELAGE FUEL TANK INSTALLATIONS UNDER CRASH CONDITIONS

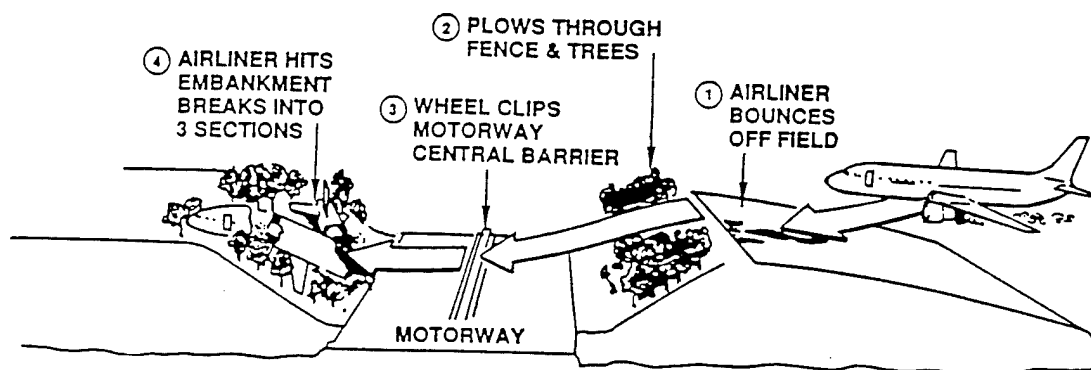
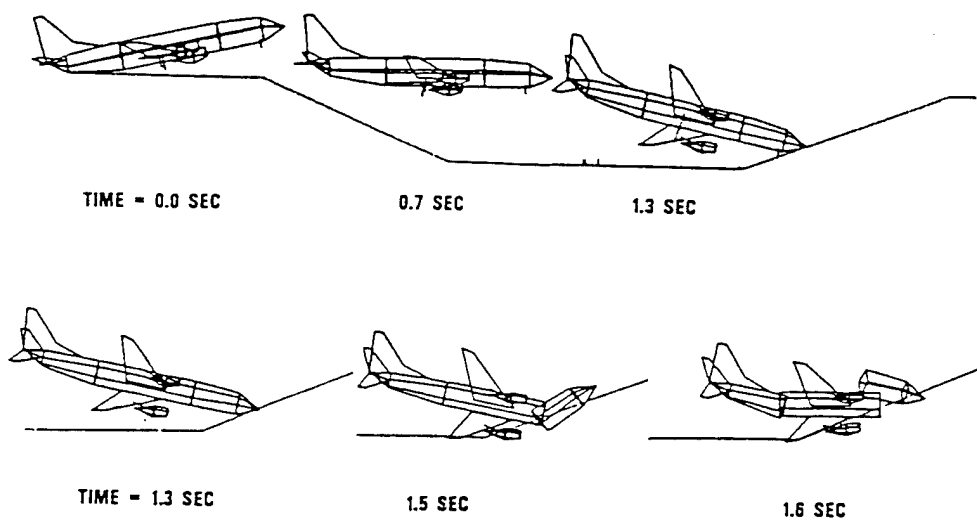
GRAPHIC DESCRIPTION OF ACCIDENT

KRASH ANALYSIS OF TRANSPORT AIRPLANE ACCIDENT

FIGURE 6. KEGWORTH ACCIDENT SCENARIO

The Kegworth accident is depicted in figure 6.

Pitch attitude	=	4.5 degrees nose up
Roll attitude	=	24.0 degrees right wing down
Yaw attitude	=	13.0 degrees nose right
Flight path velocity	=	163.5 ft/s
Flight path	=	11.0 degrees
Descent rate	=	31.7 ft/s
Terrain	=	5.0 degrees downward slope

1. two major fuselage breaks; (1) between body stations 560 and 579 and (2) between body stations 984 and 1117;
2. separation of both main landing gear;
3. extensive damage to the right wing: separated at stub;
4. impact damage to left wing: fuel tanks intact; and
5. several seats damaged: various types.

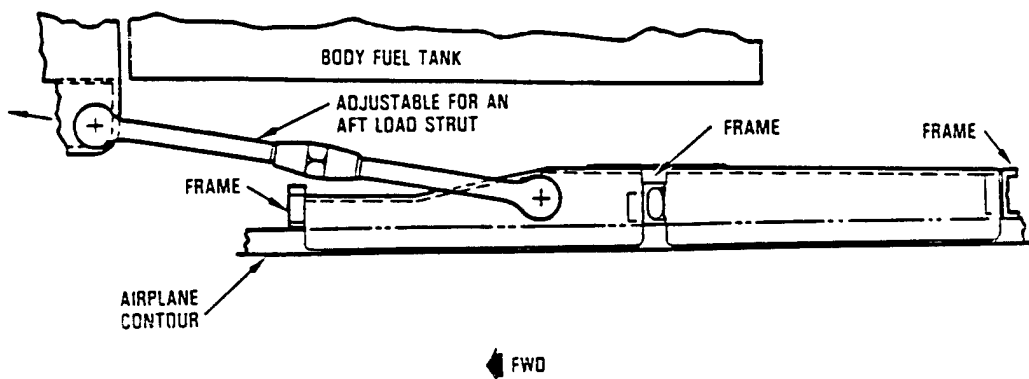
FIGURE 13. CONFORMABLE AUXILIARY FUEL TANK FORE-AFT ATTACHMENTS

The particular tanks that fit the above-mentioned installations are attached to the fuselage and floor as shown in figures 12 and 13. After consideration of available tank and fuselage configurations, it was decided to use a 500-gallon conformable tank in a B-737 fuselage section.
